Thistle Housing Association
26 Glenmore Avenue
Toryglen
Glasgow
G42 0EH

Final Report

TORYGLEN CHIMNEY INSPECTIONS SURVEY AND REPORT ON CONDITION AND REMEDIAL MEASURES REQUIRED

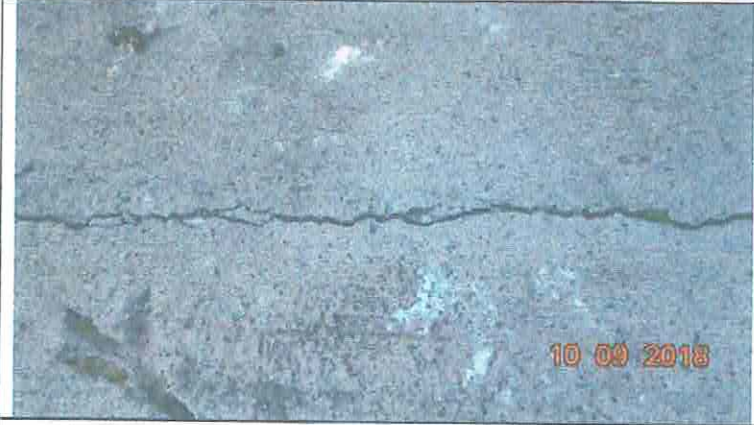
- 23/25 Ardnahoe Avenue (Central Chimney) – Reported on previously, report issued 12/09/18, where urgent remedial works were recommended.
- 25 Ardnahoe Avenue (Gable Elevation) – Hairline cracking noted around the perimeter of the chimney cope. Deemed to be stable in current condition, however perimeter cracking indicates evidence of similar defective detail being present. Client to expedite access (i.e. scaffolding) to safely remove chimney cope. Remedial detail to reinstate the overhang and drip check.

<p>23/25 Ardnahoe Avenue</p> <p>Perimeter Cracking to right hand side of chimney, resulted in section being removed by hand</p>

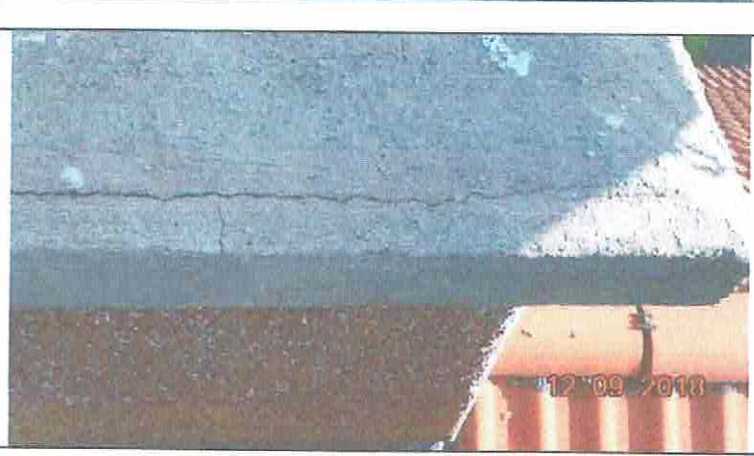
- 43 Kerrycroy Avenue (Left Chimney) – Perimeter hairline cracking noted on front right-hand corner of cope. Hairline cracking also noted on left hand edge of cope, continuing along rear edge with cracking increasing to around 1mm in thickness. Concrete tested for "looseness". Client to action expediting access for safe removal of concrete and remedial measures to reinstate overhang and drip check.

- 43 Kerrycroy Avenue (Right Chimney) – Perimeter hairline cracking noted on front edge of cope. Hairline cracks are also noted running from front edge to 3 of the 4 chimney pots. Hairline cracking also noted on left hand edge of cope, continuing along rear edge. Concrete tested for "looseness". Client to action expediting access for safe removal of concrete and remedial measures to reinstate overhang and drip check.

<p>43 Kerrycroy Avenue</p> <p>Perimeter cracking to rear side of cope</p>

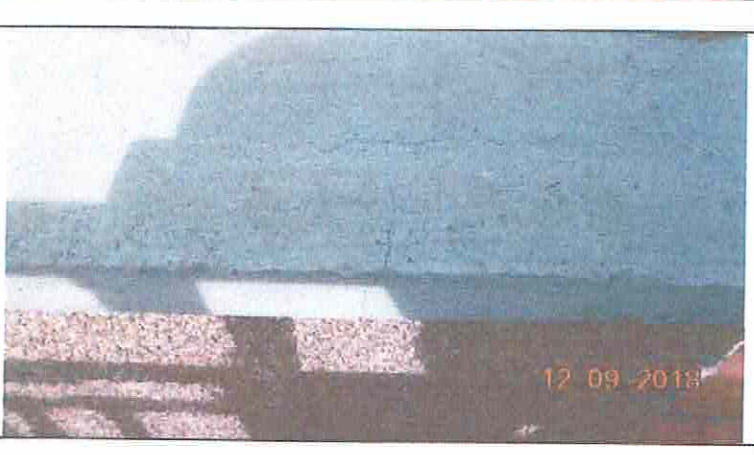
- 47 Kerrycroy Avenue (Left Chimney) – Hairline perimeter crack noted on front left-hand side edge, continuing onto left hand edge of cope. 0.5mm shrinkage cracking noted from 2 no. chimney pots running to edge of cope. Client to action expediting access for safe removal of concrete and remedial measures to reinstate overhang and drip check.

- 47 Kerrycroy Avenue (Right Chimney) – Hairline perimeter cracking noted to right hand edge of cope. Further perimeter cracking noted to a section approximately 800mm long on front edge. Remaining cracking between chimney pot and edge of cope considered shrinkage. Client to action expediting access for safe removal of concrete and remedial measures to reinstate overhang and drip check.

<p>47 Kerrycroy Avenue</p> <p>Hairline perimeter cracking noted to front side</p>

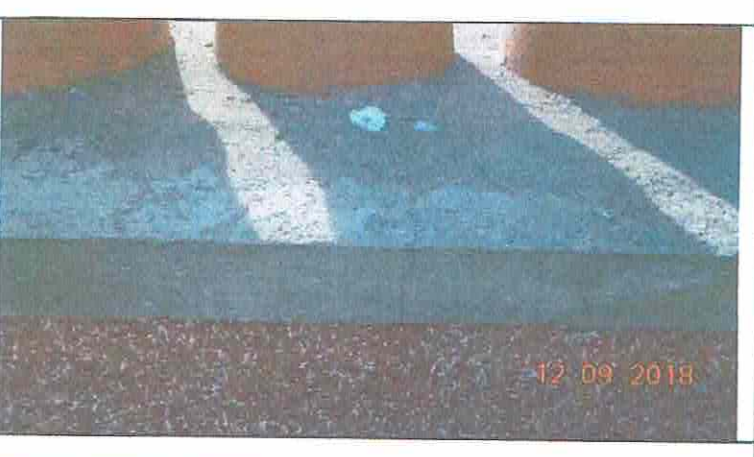
- 10 Kerrycroy Street (Left Chimney) – 1 No. shrinkage cracking noted from 1 no. chimney pot to front edge. Thistle Housing Association carried out retrospective survey, see Ad-Hoc survey notes below.

- 10 Kerrycroy Street (Right Chimney) – 1 No. shrinkage cracking noted from 1 no. chimney pot to front edge. Thistle Housing Association carried out retrospective survey, see Ad-Hoc survey notes below.

<p>10 Kerrycroy Street</p> <p>Typical shrinkage crack between chimney stack and edge of cope</p>

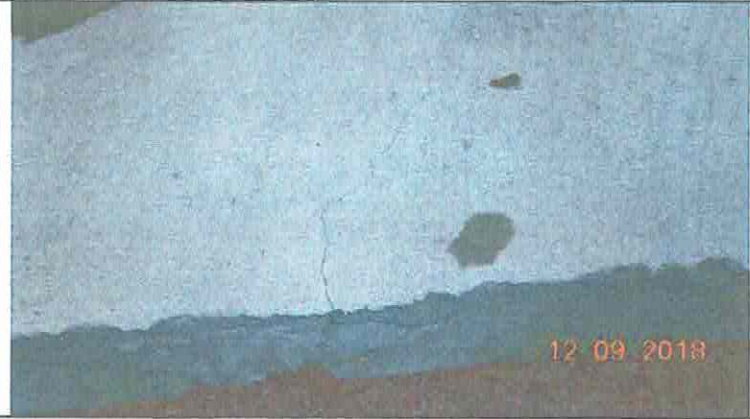
- 6 Kerrycroy Street (Left Chimney) – 2 No. shrinkage cracking noted from 2 no. chimney pots to front edge.
- 6 Kerrycroy Street (Right Chimney) – 2 No. shrinkage cracking noted from 2 no. chimney pots to front edge.

<p>6 Kerrycroy Street</p> <p>Typical shrinkage crack between chimney stack and edge of cope</p>

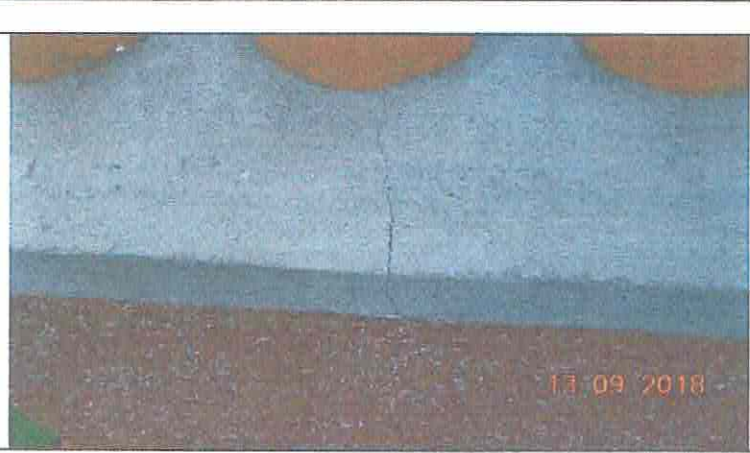
- 48 Kerrycroy Avenue (Left Chimney) – 3 No. shrinkage cracking noted from 3 no. chimney pots to left and right edge.
- 48/50 Kerrycroy Avenue (Central Chimney) – No cracking noted.

<p>48 Kerrycroy Avenue</p> <p>Typical shrinkage crack between chimney stack and edge of cope</p>

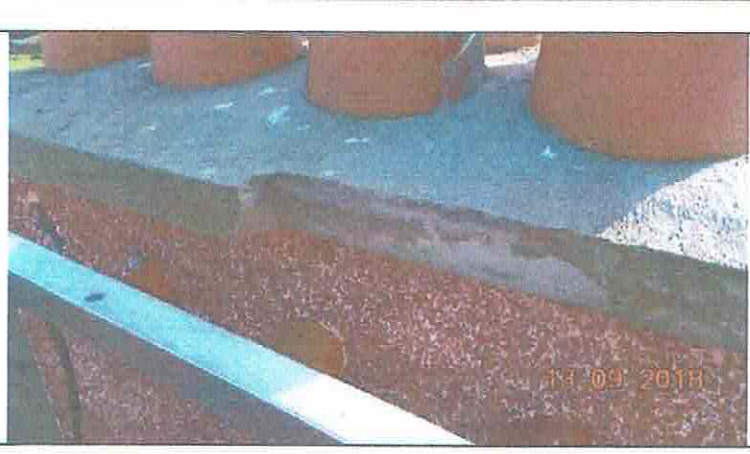
- 17/19 Ardnahoe Avenue (Central Chimney) – Loose section of perimeter concrete removed to left hand/front edge corner approximately 900mm in length. Repairs required to be carried out to reinstate overhang and drip check at section removed.

<p>17/19 Ardnahoe Avenue</p> <p>Section of concrete removed from cope</p>

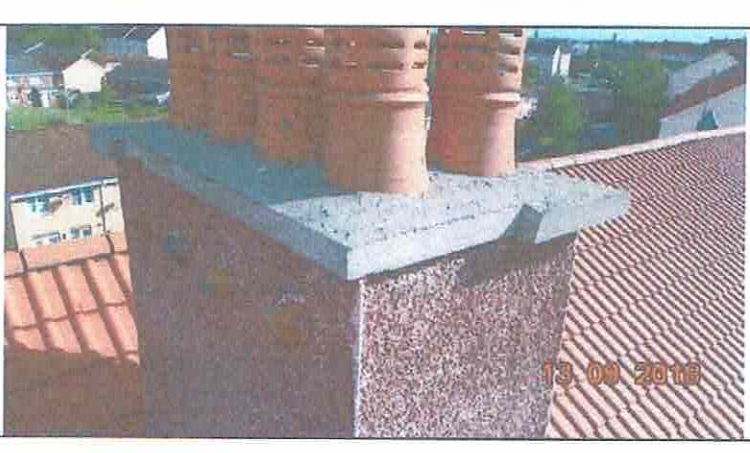
- 19/21 Ardnahoe Avenue (Central Chimney) – Large sections of loose perimeter concrete removed. Left hand side edge removed in its entirety along with the front edge cope. Repairs required to be carried out to reinstate overhang and drip check at section removed.

<p>19/21 Ardnahoe Avenue</p> <p>Section of concrete removed from cope</p>

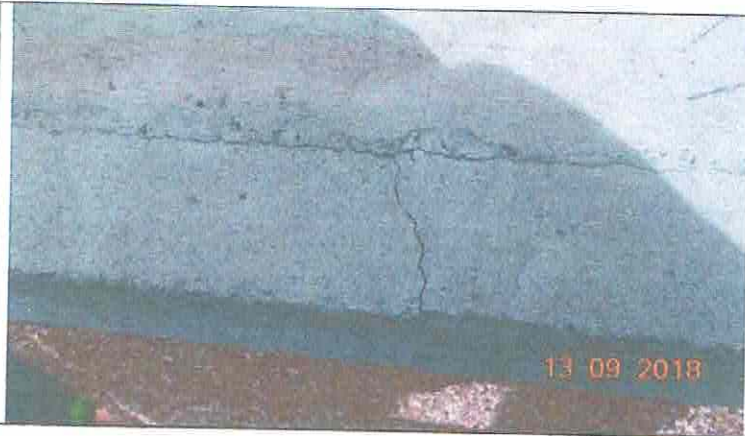
- 3-7 Kerrylamont Avenue (Left Chimney) – Significant perimeter cracking noted on the front, left and right edge of the cope. Client to action expediting access for safe removal of concrete and remedial measures to reinstate overhang and drip check.

Perimeter Cracking to right hand side of cope

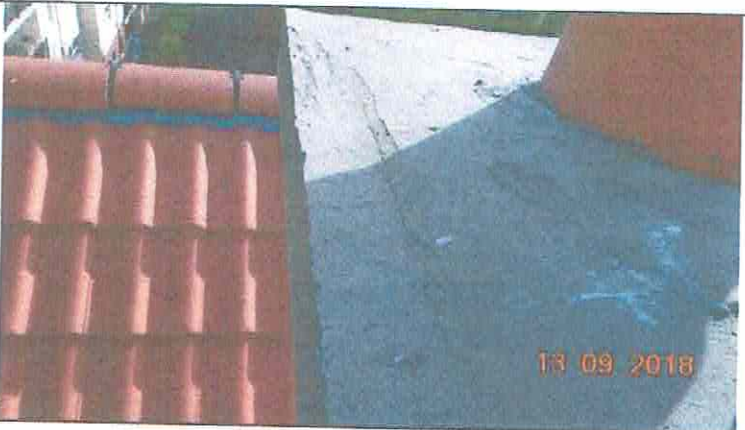
3-7 Kerrylamont Avenue

Perimeter Cracking to left hand side of cope

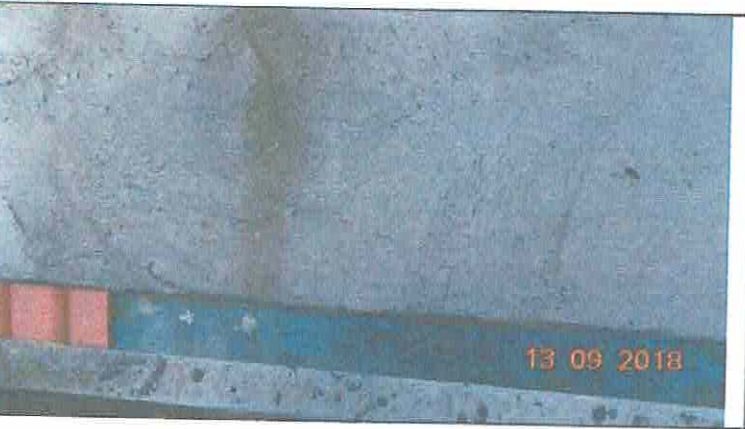
51 Kerrycroy Avenue (Left)

- 51 Kerrycroy Avenue (Left Chimney) – The left hand/rear corner of the cope has a hairline perimeter crack. A further hairline shrinkage crack is noted from 1 no. chimney pot to the edge of the cope. Client to action safe removal of concrete and remedial measures to reinstate overhang and drip check.

Hairline perimeter cracking to left/rear side of chimney

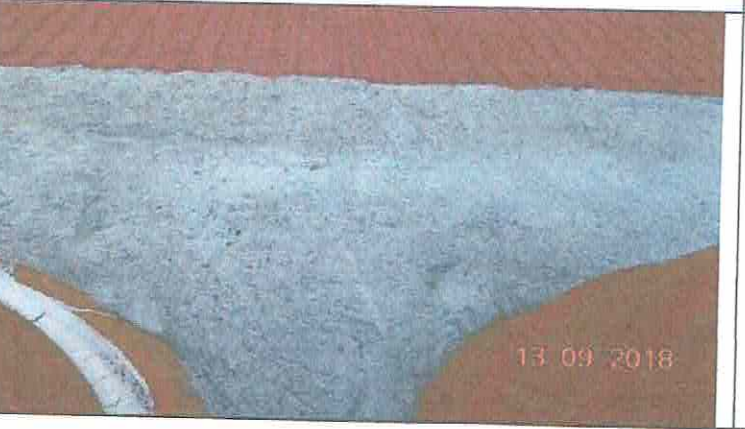
51 Kerrycroy Avenue (Right)

- 51 Kerrycroy Avenue (Right Chimney) – Hairline perimeter cracking noted to right hand edge of cope. Further perimeter cracking noted to a section approximately 800mm long on front edge. Remaining cracking between chimney pot and edge of cope considered shrinkage. Client to action safe removal of concrete and remedial measures to reinstate overhang and drip check.

Perimeter Cracking to right hand side of cope
